# VERNACULAR BUILDING 35

## Scottish Vernacular Buildings Working Group

2011–2012

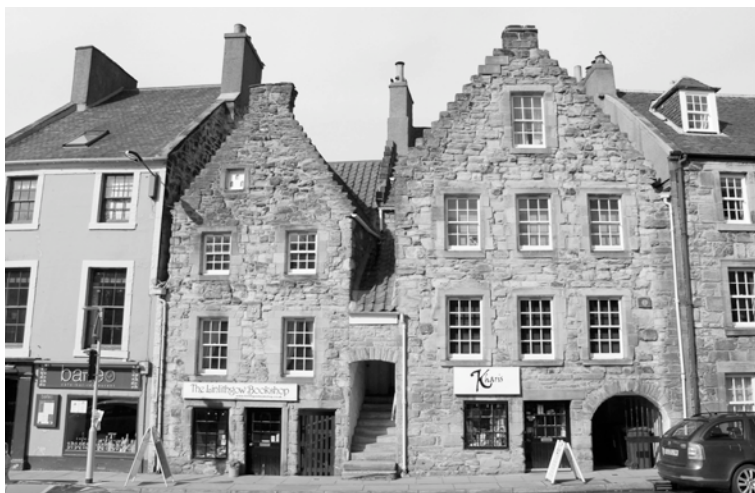
*Figure 1. The main frontage of Hamilton's Land on the north side of Linlithgow High Street. (© National Trust for Scotland)*

The building known as Hamilton's Land (42–44 and 46–48 High Street, Linlithgow) was gifted to the National Trust for Scotland (the Trust) in 1938 by Mr J G B Henderson. It stands at the east end of the High Street on the north side and comprises two houses, three storeys and a garret high (fig.1). Both have crowstepped gables facing south onto the street. It is believed to date from the late sixteenth to early seventeenth century, with written records naming the earliest owner as James Robertson in 1541 and the property transferring to a Mungo Hamilton of Humble some time before 1616. However, the historical records give no indication of other inhabitants of the building (the 'indwellers' or 'unfreemen'), concentrating as they do on the owners alone. This has long been a problem in our study of medieval urban dwellings,<sup>1</sup> though it is

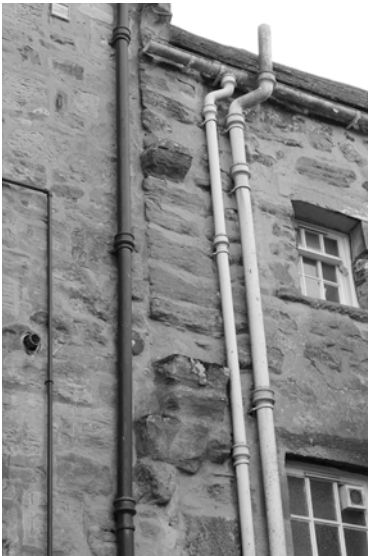
*Figure 2. Skews on the building's rear elevation may be remnants of the now demolished backland structures or evidence of the buildings once having a considerably lower roofline.  
(© National Trust for Scotland)*

At the rear of the building it was possible to see the remnants of skews or corbels (fig.2) which may have acted to support the timbers for the structures within the backlands or alternatively be evidence of earlier roof heights.

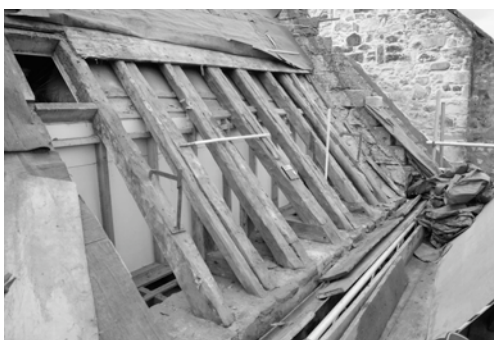
*Figures 3 and 4. Views of the exceptionally well-preserved roof timbers and ashlar posts on the building's north pitch. (© National Trust for Scotland)*

The roof's northern pitch was found to have survived in a good state of repair (figs 3 and 4) and was of a common collared rafter form with many of the original collar and rafter pairs surviving. Some of the rafter pairs were still mortised and tenoned to original sole plates and ashlar posts.

This northern pitch of the roof had been extensively repaired over the years, with nine adze-trimmed timbers nailed to the original rafters to strengthen the roof and four modern timbers nailed and bolted to the rotten lower ends of various rafters. In addition, further strengthening had occurred above the original collars in the form of circular-sawn timber nailed to the majority of the rafter pairs.

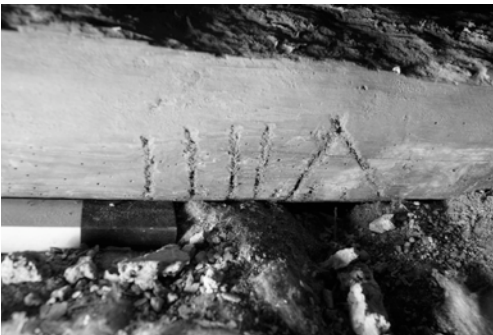
*Figure 5. An example of the masons' marks found on the rafters and collars. (© National Trust for Scotland)*

Various features were noted on the original rafters, including two opposing pairs of vertical grooves, a small bridle beam and another pair of opposing shallow recesses. A complete sequence of assembly marks was present on the western-facing sides of the nine central rafters and collars. These were found in ascending order from 'I' to 'VIII' (fig.5).

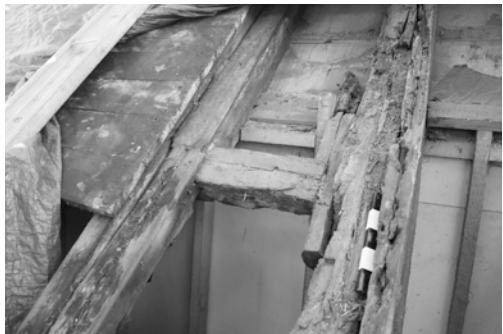
*Figure 6. One of the bridle beams fixed to both the east and west pitch of the south roof. (© National Trust for Scotland)*

Of note within this element of the roof structure were two large bridle beams fixed to both the east and west pitches (fig.6). Both bridles were tenoned into mortised shoulders which were nailed

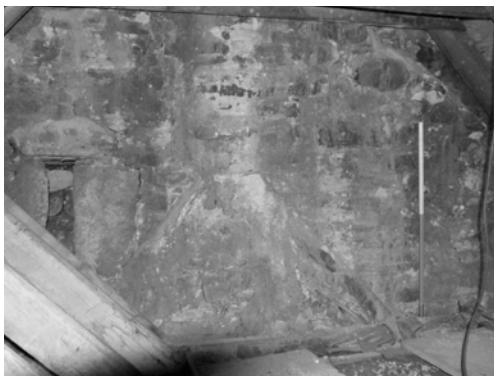
*Figure 8. Evidence in the form of a raggle line on the west gable end of 42–44 High Street, preserved in the roof space of numbers 38–42. (© National Trust for Scotland)*

Given the existence of external skews on the north face of the building and the evidence for the two-phase development of the roof structure, it would seem not unreasonable to conclude that the building was once a lower two-storey structure. Furthermore, the analysis described above also seems to point towards the conclusion that the building was at some stage set back from the High Street and that, in keeping with many historical burgh high-street buildings (see for example Gladstone's Land on Edinburgh's Royal Mile), it may have possessed a timber and/or a colonnaded stone frontage. This may well explain why steel I-beams were incorporated halfway along the property; a necessary response to the removal of the original frontage. Pont's map dating to 1630 shows arcaded buildings along Linlithgow High Street in the late sixteenth century (although Slezer's 1693 engraving does not).<sup>7</sup> This is further supported by the analysis of the preserved gable end within the adjacent building. Within the roof of numbers 38–42 on the High Street it is possible to see evidence of a lower two-storey building. This earlier building has left the scar of the roofline of a lower structure along with the remnants of a cope (fig.8).

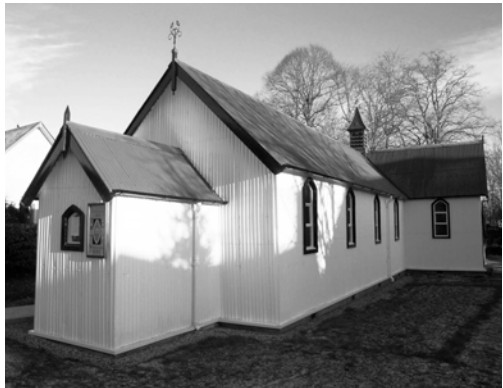
*Figure 1. St Fillan's  
Episcopal Church,  
Killin after repair in  
2011.*

St Fillan's Episcopal Church (fig.1) is prominently sited within the small rural village of Killin in the Loch Lomond and The Trossachs National Park. It is currently listed at category C(S), and was built in 1876 by the 7th Earl of Breadalbane to serve members of his shooting parties. It is locally known as the 'Grouse Chapel', and represented the first ministration for Episcopalians in the Killin area since 1716.

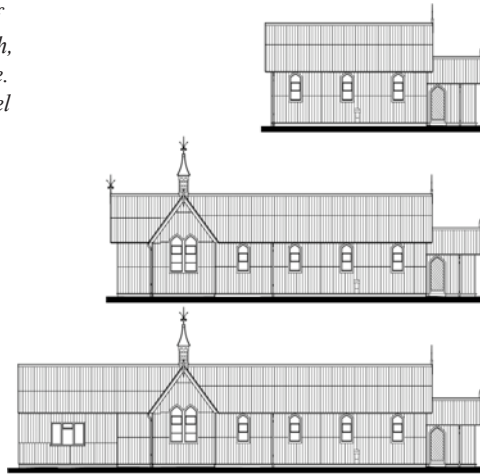
Figure 5. North elevation of St Fillan's Episcopal Church, showing extension over time. (top:) 1876 – original chapel 3 bays long with west porch (middle:) 1885 – crossing section and 1 bay added to the chapel (bottom:) 1969 – meeting room extension added.

original church was in fact only three bays in length and including the west porch (figs 2 and 5). The 1969 extension is built against the east gable of the church: the gable itself is retained and thereby the integrity of the church building. An attractive circular stained-glass window depicting the Annunciation set into the gable, although now enclosed, it is still visible internally.

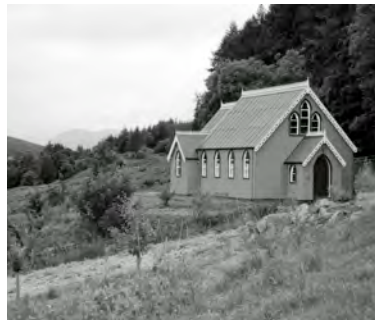
*Figure 6. The former Roman Catholic chapel of Our Lady of Mercy was gifted by the 3rd Marquis of Bute to Aberfeldy in 1885. Recently replaced by a new-build church, the tin tabernacle has been reconstructed in the village of Dull by a private individual. The church originally had a bell tower above the tripartite window which blew down in the 1940s.*

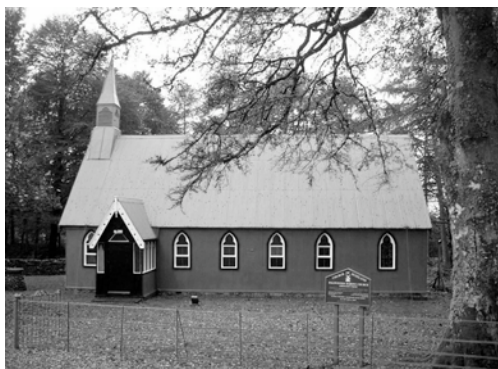
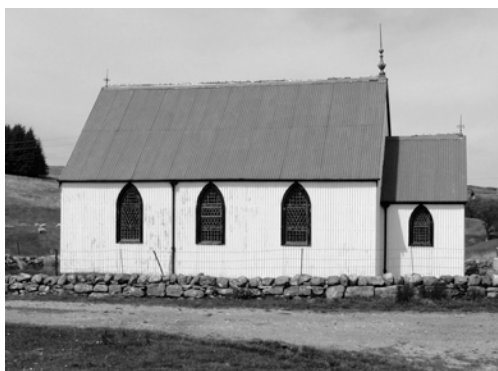
*Figures 7 and 8. Dalswinton Barony Church, Dumfries and Galloway (above; 1881) and Syre Church, Sutherland (below; 1891) provide fine examples of the decorative qualities of early tin tabernacles. Syre has lost most of its decorative ridge brattishing, but retains leaded 'gothic'-style windows. (Dalswinton image reproduced under Creative Commons Licence, author Rosser 1954)*

have been established in 1877 and moved in 1884.<sup>12</sup> These two churches are part of a group of 11 known to date from before 1900 (see Appendix, table 5). There are clear stylistic differences between the early churches and the post-1900 churches. The early churches are more ornate, in many respects attempting to imitate traditional church architecture, with decorative features such as arched windows which are found in a number of the surviving examples (figs 7 and 8).

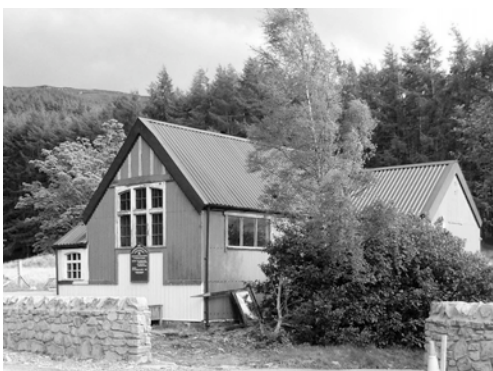
*Figure 10. St Fillan's Episcopal Church: arched window construction exposed during the repair works (2011). Note, a perfect place for wasps!*

Arched openings were more problematic to cut neatly in corrugated sheeting; for example, the triangular-headed windows at Fort Augustus are actually made up with the addition of flat metal plates.<sup>17</sup> At St Fillan's the arched openings are cut from the corrugated sheet and supported on arched timber framework (fig.10). In addition to ecclesiastical references, this may also make reference to the 'gothic' style employed by the Breadalbane

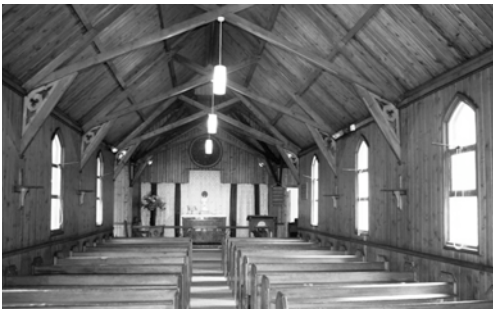
*Figure 11. St Fillan's Episcopal Church: the attractive pitch pine interior so characteristic of the church.*

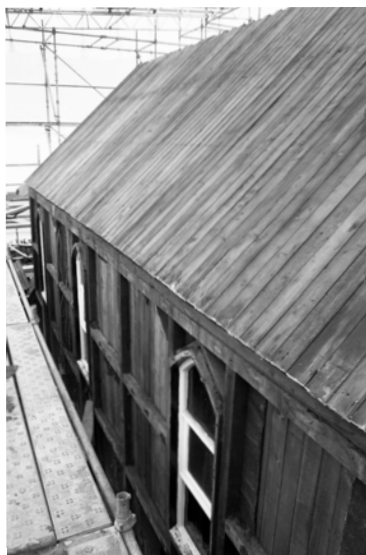
*Figure 13. St Fillan's Episcopal Church: the corrugated-iron sheeting removed, the timber shell of the building is revealed (2011).*

In comparison to the wall sheets, the corrugated-iron roof sheets were in a poor condition, suffering with corrosion and distortion. A protective canopy was erected over the church to allow the roof to be fully stripped for inspection (fig.13). The original felt was saturated, soaking the timber sarking boards (which also act as the internal ceiling linings). It was discovered that laps between sheets and especially at the ridge were very small, allowing water to penetrate into the church and putting the timber interior at risk.

Despite the saturation of the roofing felt, the original pine boards were in good condition apart from at the ridge. Here the uppermost purlin was suffering from wet rot in several places, and in general across the roof the nails attaching the boards to the purlins had failed. Rot damage to the ends of the boards at the ridge made re-nailing to the original purlin impossible. So a new purlin was fixed below the original one, which had the added advantage of allowing the majority of the damaged linings to be retained (the purlin covering the damaged ends internally).

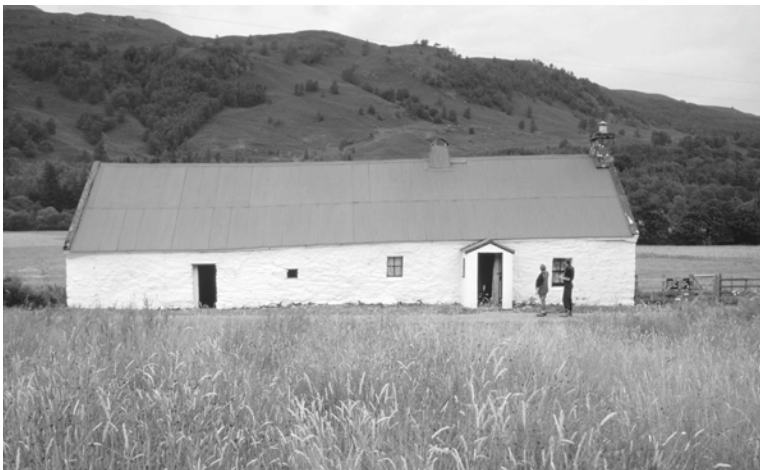
*Figure 1. The present Moirlanich Longhouse.*

Surviving thatched buildings are increasingly rare, so it is important that we learn as much as we can from them. Moirlanich Longhouse, near Killin in Perthshire, is a well-known visitor attraction and one of Scotland's best-preserved vernacular buildings (fig.1). Occupied until the 1960s, it was purchased by the National Trust for Scotland in 1992, complete with many original internal

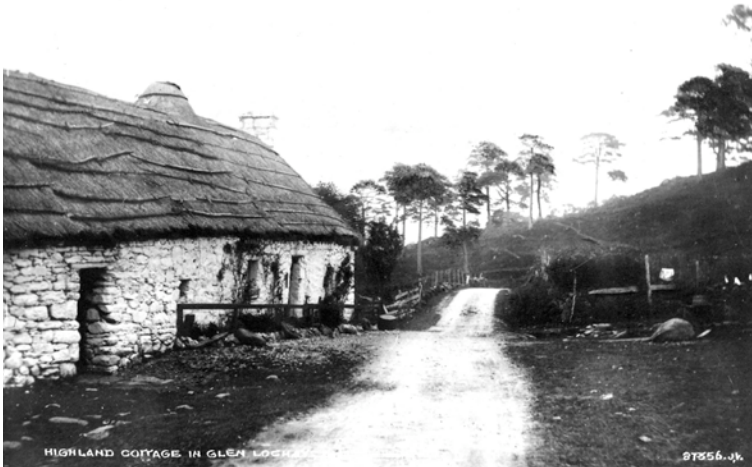
*Figure 2. The dwelling from a postcard by James Valentine, c.1918.*

fixtures and fittings and a historic thatch protected by an outer roof of corrugated iron. The single-storey building with five cruck couples is thought to have late eighteenth- or early nineteenth-century origins (fig.2) but the corrugated roof is a 1930s addition. The east three-and-a-half bays form a dwelling with a gable chimney and a canopy chimney part-way along the ridge. The remaining two-and-a-half bays were most recently used as a byre.

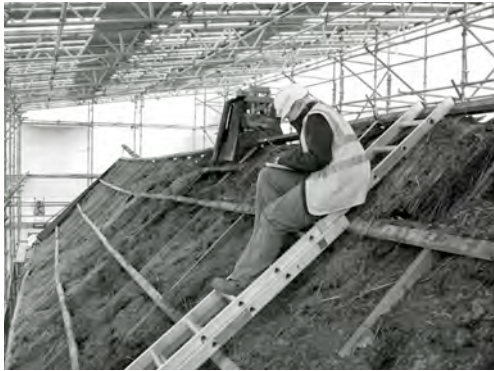
*Figure 3. The roof exposed and recording underway.*

obscures the structure beneath, but even at this early stage at Moirlanich it was clear that there was a difference between the two ends of the longhouse. The west end comprised quantities of loose cereal straw and exposed turf, whereas the east end was more soot-blackened and displayed clear evidence of the use of bracken.

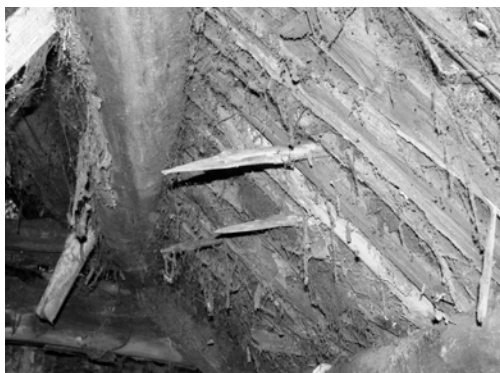
*Figure 5. The sharpened crooks projecting into the interior.*

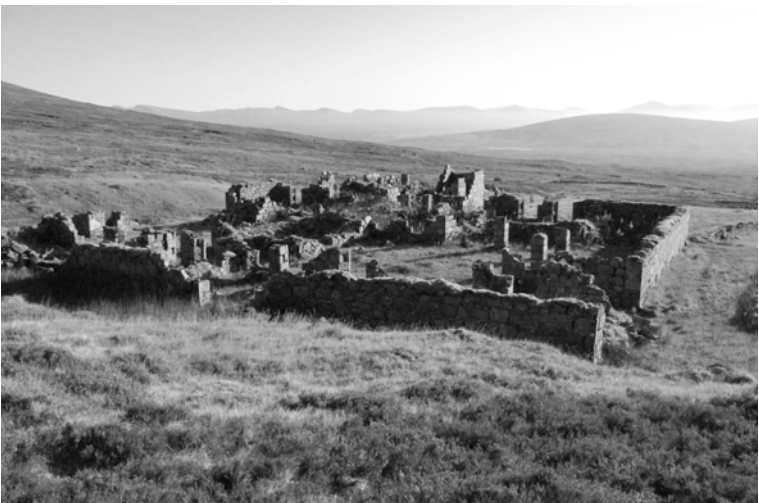
*Figure 1. Corrou Old Lodge from the north, towards Rannoch Moor (October 2010).*

Corrou Old Lodge (NN 408 648) (fig.1) is a ruined shooting lodge, built probably in the first half of the nineteenth century. It should not be confused with the later Corrou Lodges, five kilometres (three miles) away, at the east end of Loch Ossian. The Corrou estate, land once held by the MacDonnells of Keppoch and by their feudal superiors, the Dukes of Gordon, was sold in 1834 to John Walker Esq. of Crawfordton, a merchant from Dumfries.<sup>1</sup> His son, Colonel Sir George Gustavus Walker, sold it to Sir John Stirling Maxwell of Pollok in 1891, three years before the new West Highland Railway was opened.<sup>2</sup>

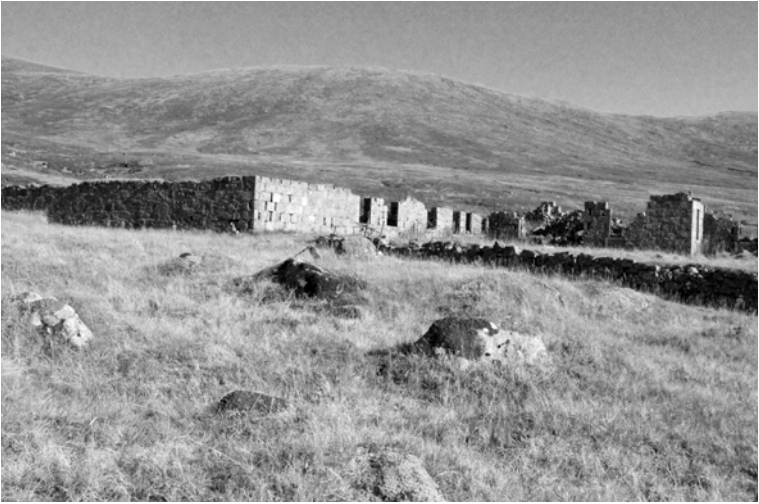
*Figure 2. Corroual Old Lodge from the west (October 2010).*

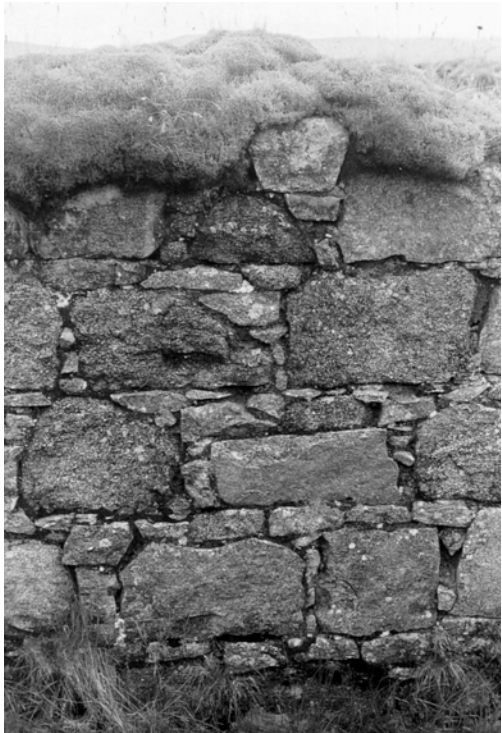
*Figure 3. Detail of wall construction (north wall, north range).*

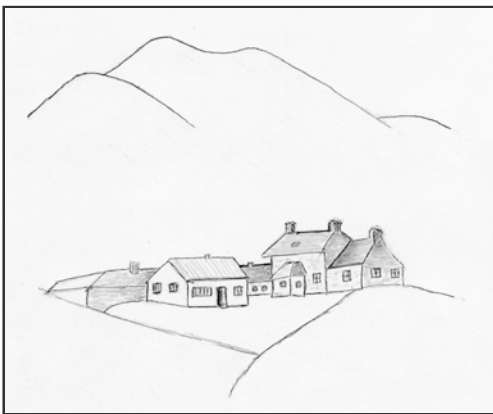
*Figure 6. Corroul Old Lodge before 1900: drawing based on a sketch made by Miss Violet Montgomery in 1896.*

compared with a lesser amount at the south end of the wing, which is shown with a lower roof level. There may have been at least a partial stone stair, and sleeping room in the loft space. The sketch shows a skylight. The lodge would have been capable of accommodating at least half a dozen guests (there were six signatures at the side of the sketch, including that of John Stirling Maxwell himself). Other bedroom accommodation may have been in the east or west wing (for instance, KLMP, MNOP, DQVY); and one could even postulate an ‘owner’s room’, with the best view, in the southmost, lower-roofed extremity.

EFGH is the porch, clearly seen in the 1896 sketch (see fig.6). The door is on the sheltered north side EF; a window (no.9), facing west, has suffered damage since 1995; one side is now 'crow-stepped'. GH has an unusually tall window (no.10), and is one of the only two windows in the whole complex still (2011) with an intact upper lintel. HE, at the rear of the porch (not outlined on the diagram), is one of the highest points of the structure standing, and could represent the remains of a chimney.

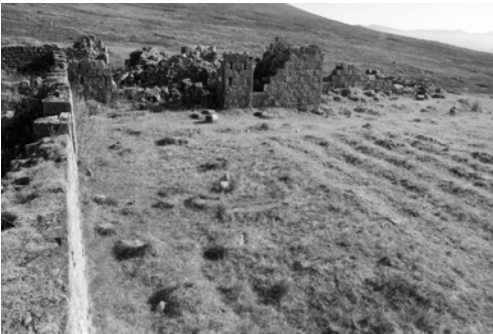
*Figure 8. West side of Corrou Old Lodge, with porch (2010); note flat area and ‘furrows’.*

On the west side, six south-facing windows gave a good view over the moor – at least, before the postulated ‘iron house’ was erected in front of them. Foundations may well remain in front of the windows; there is a flat area beyond, then seven or eight east–west stony rows and furrows opposite the porch (figs 8 and 9). Beyond the western corner of this wall is a long windowless

DE appears to have been intact in 1986, but its southern section, beyond a door, has since collapsed and a rubble pile beyond is exposed (see figs 7 and 8).

To the front of the lodge, a flat area immediately outside the south-facing wall of the west wing gives way to seven or eight parallel rows of furrows and stones, outside the entrance porch to the lodge (see figs 8 and 9). These may represent foundations, and seem to coincide with the site of what could have been the ‘iron house’, or the small building shown on Miss Montgomery’s 1896 sketch.

Evidence of the gradual degradation of the structure has been noted in photographs of the eastern aspect in 1986, 1995 and 2010 (figs 10 and 11) and of the western aspect of the south wing in 1995 and 2010 (see figs 8 and 9). Comparison of these shows how sections of the walls have collapsed between these dates (fig 12). Walls DE, FG and JKL have certainly suffered during these 15 years.

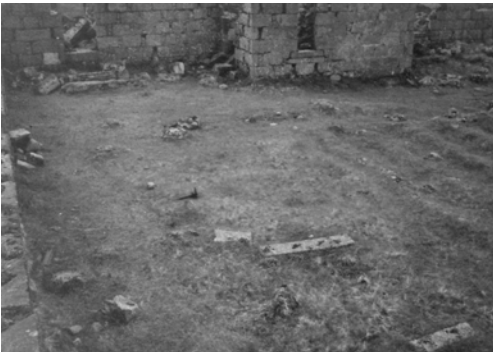
*Figure 9. West side of Corrou Old Lodge, with porch (1995); note intact wall to left of porch.*

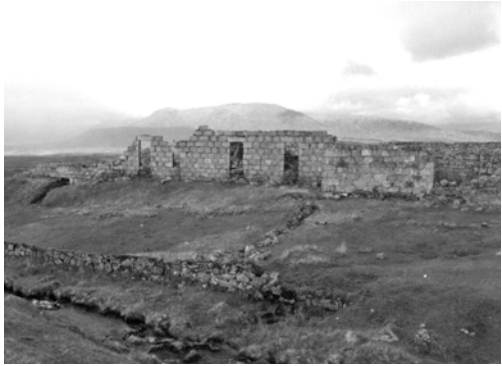
Figure 11. Corrou Old Lodge from the south-east. (October 2010)

JK is a long (24-metre (79-foot)) stretch of wall, with one drain (aperture no.13) at its south end, and five windows (nos 14–18). Window no.16 is the second of the two windows still with intact lintels. Nos 15, 17 and 18 still had lintels in 1986, but only the last was still complete in 1995 (figs 10, 11 and 12). The northern end of the wall, just before corner K, is one of the highest parts of the ruins, at least ten courses in height.

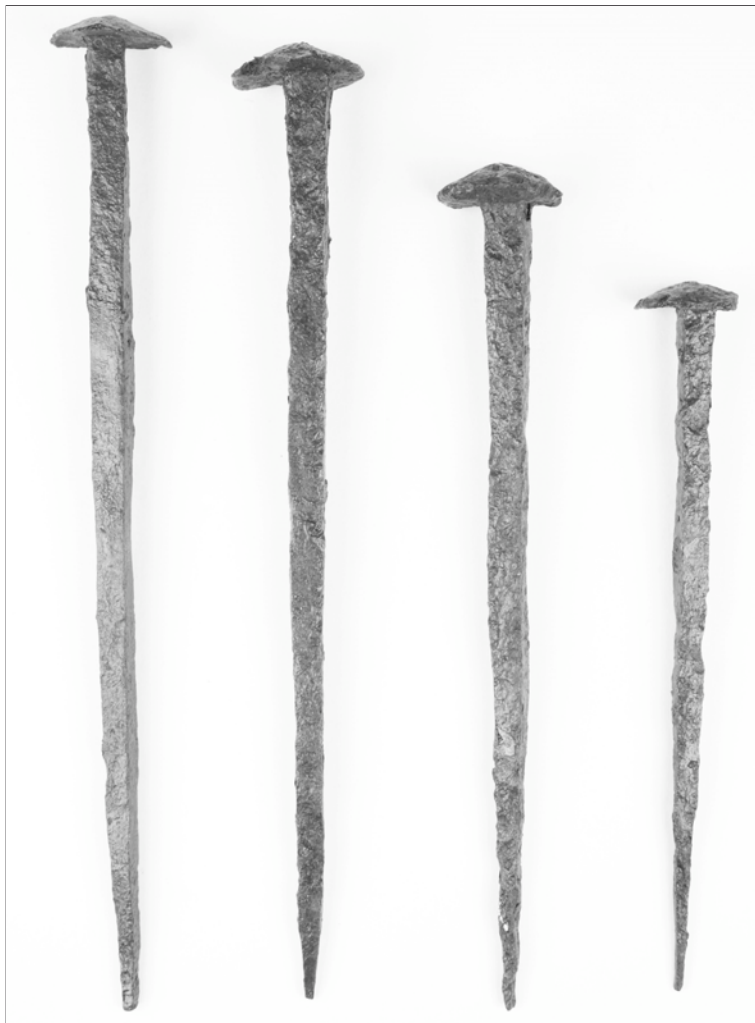
*Figure 3. Hand-wrought nails recovered from the 1st-century AD hoard of Roman nails discovered in the 1950s at Inchtuthil, Perthshire. The left-hand nail is 35 cm (13¾ in) long. (© The Hunterian, University of Glasgow 2012)*

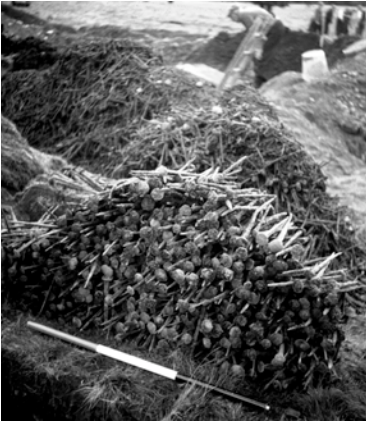
*Figure 4. Part of the original Inchtuthil hoard. (© Royal Commission on the Ancient and Historical Monuments of Scotland. Licensor [www.scran.ac.uk](http://www.scran.ac.uk))*

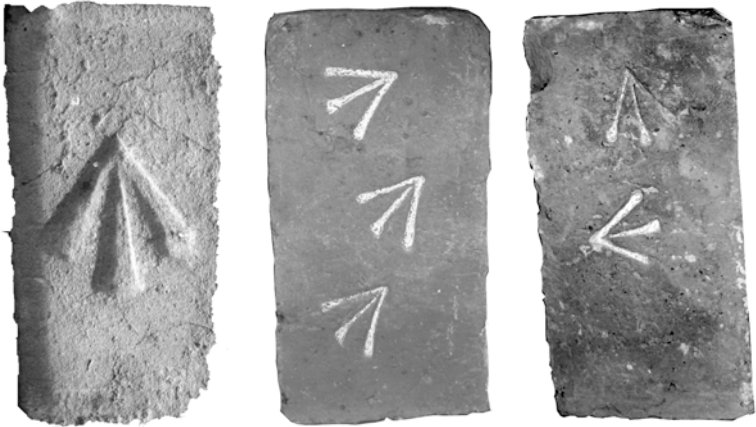
*Figure 2. The 'penal arrow' mark introduced to identify the wares of state-owned brickworks. Each penal settlement used a different configuration, including Parramatta (left) and Tasmania (middle). (The source of the right-hand example is unidentified.)*

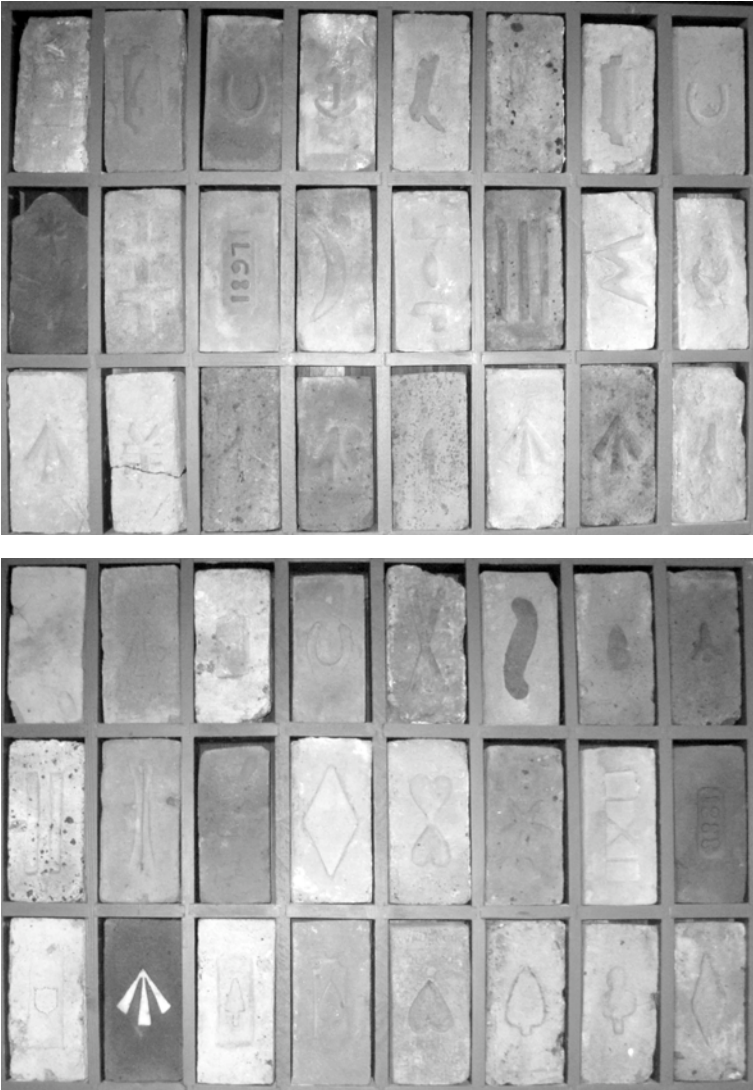
*Figure 4. The frog marks of various independent brickmakers.*

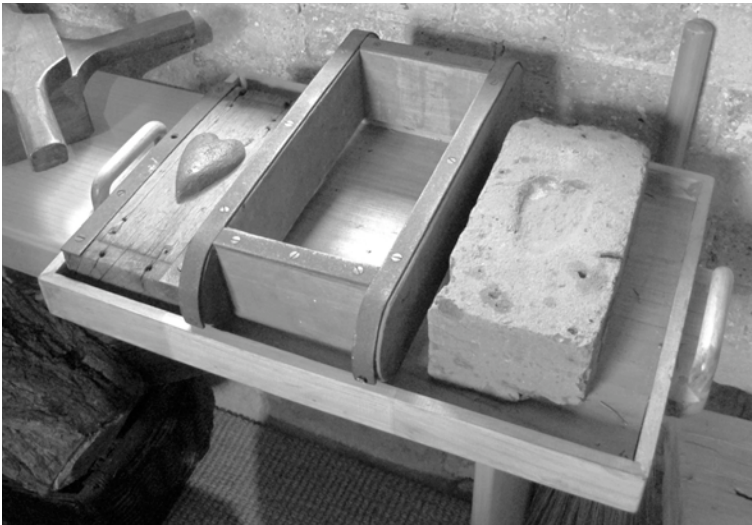
*Figure 5. Brickmaking equipment: the stockboard with heart-shaped kick (left), the mould (centre), and a finished brick (right).*

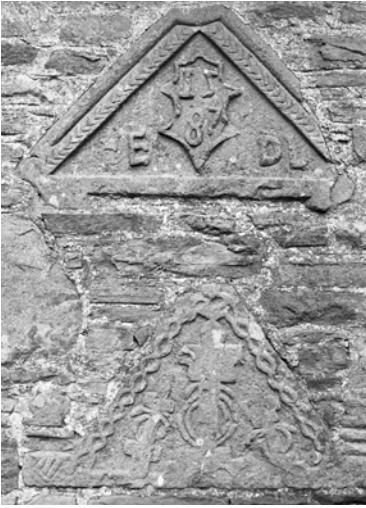
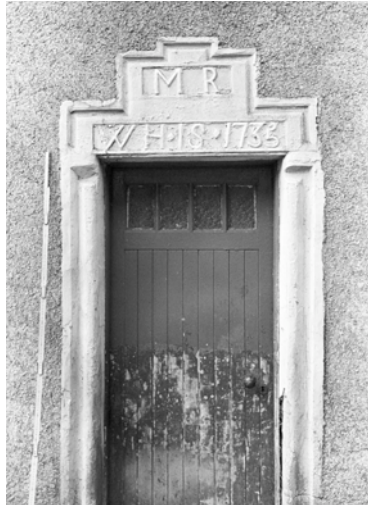
*Above: Examples of architectural details captured by the Buildings of the Scottish Countryside survey. From Kirkton of Monikie, Angus, and Crossburn Farm, Stirling, respectively. (© Scottish Natural Heritage; courtesy of RCAHMS)*

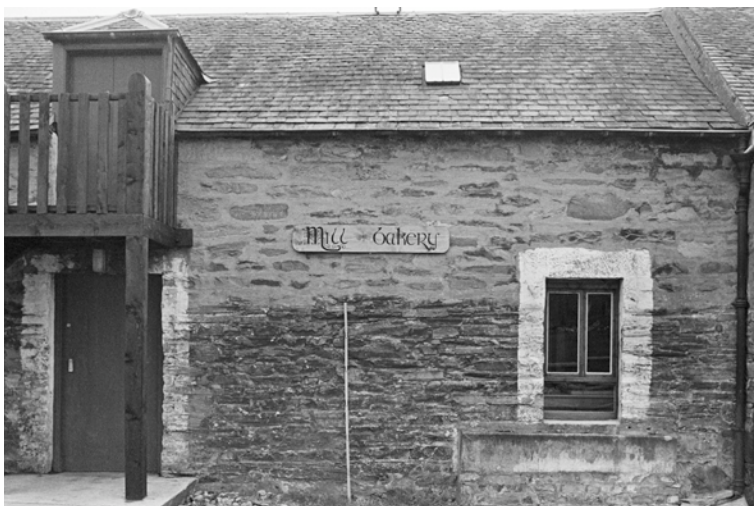
*Above: The survey's scope was not restricted to domestic architecture. This mill and bakery in Blair Atholl, Perthshire, is one of a number of small commercial and industrial buildings that were also photographed. (© Scottish Natural Heritage; courtesy of RCAHMS)*

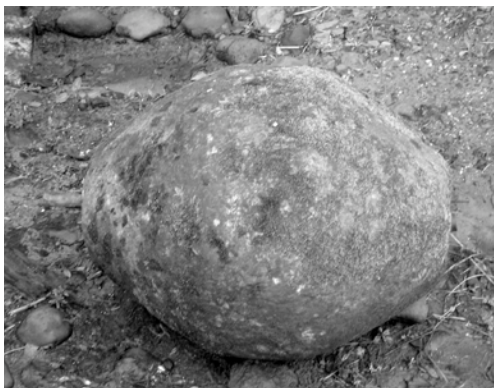
*Right: The whin stone at Dalgarnen Mill, North Ayrshire. The pins at either end of the stone (more prominent on the left-hand end) acted as an axle so that a horse could pull and roll the stone across whin to crush the plant to make it palatable for animals.*

The image is not of the stone at the Wester Kitchochside museum but of one at the Museum of Ayrshire Country Life and Costume, at Dalgarnen Mill in Kilwinning, Ayrshire.
